**ROAD SAFETY AUDIT  
PLYMOUTH STREET  
(ROUTE 106)  
AT  
WASHINGTON STREET,  
EAST BRIDGEWATER, MA**

**OLD COLONY PLANNING COUNCIL,  
70 SCHOOL STREET, BROCKTON, MA 02301  
WWW.OCPCRPA.ORG  
PREPARED UNDER MASSDOT CONTRACT # 0052455  
SEPTEMBER, 2011**

# Road Safety Audit of Plymouth Street (Route 106) at Washington Street, East Bridgewater Final Report

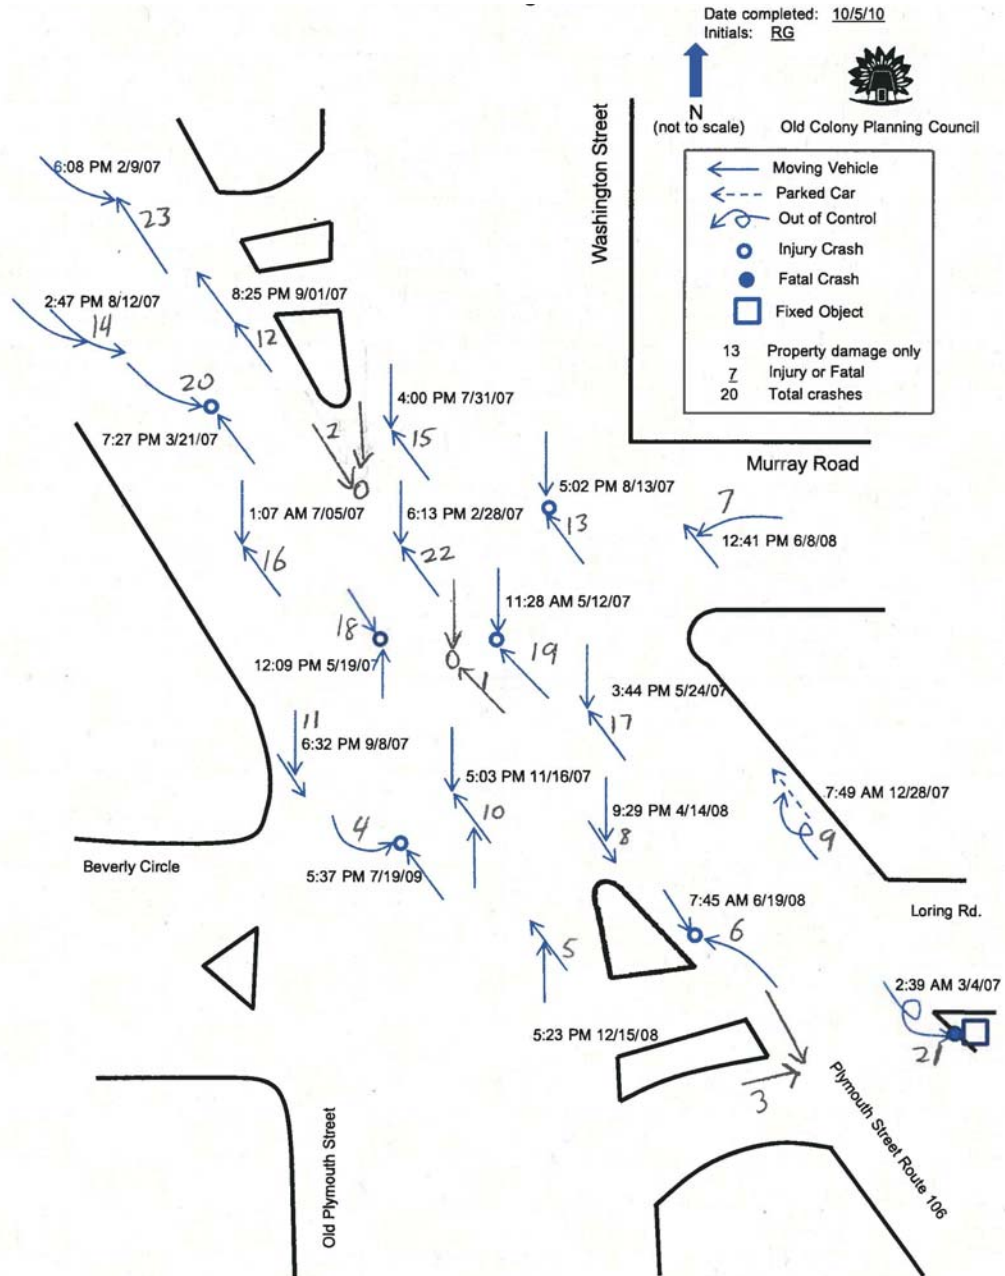
**Figure 4: Collision Diagram for Plymouth Street (Route 106) at Washington Street, Old Plymouth Street, Murray Road, and Beverly Circle**

Table 2 and Figure 4 summarize collisions occurring at the intersection from 2007 through 2010. The most frequent manner of collision occurring at the intersection is between vehicles arriving on the westbound approach of Plymouth Street (Route 106) and the southbound approach of Washington Street, accounting for 8 of the 23 reported crashes occurring at this intersection from 2007 through 2010. The second most common type of collision was between vehicles arriving on the opposing approaches of Route 106. Four collisions were between vehicles arriving on opposite Route 106 approached, categorized as either a head-on collision or an angled collision (one vehicle turning left in front of the other). Three of the reported collisions were between vehicles arriving on the eastbound approach of Route 106 and the southbound approach of Washington Street. Nearly half (eleven) of the reported crashes involved vehicles arriving on the southbound approach of Washington Street.

Slightly more than one-third (34.78%) of the crashes occurring at this intersection resulted in injury. There was one report of a fatal crash at the intersection, on March 4, 2007.

According to police reports, eight of the collisions involved drivers failing to stop at the stop signs on Washington Street and Old Plymouth Street.

The intersection has a very high crash rate of 1.34 crashes per million entering vehicles. This crash rate is more than double (123%) of the 2011 regional MassDOT District Five average crash rate (0.60) for un-signalized intersections.
